# Diagram # 5030

Repair Harness

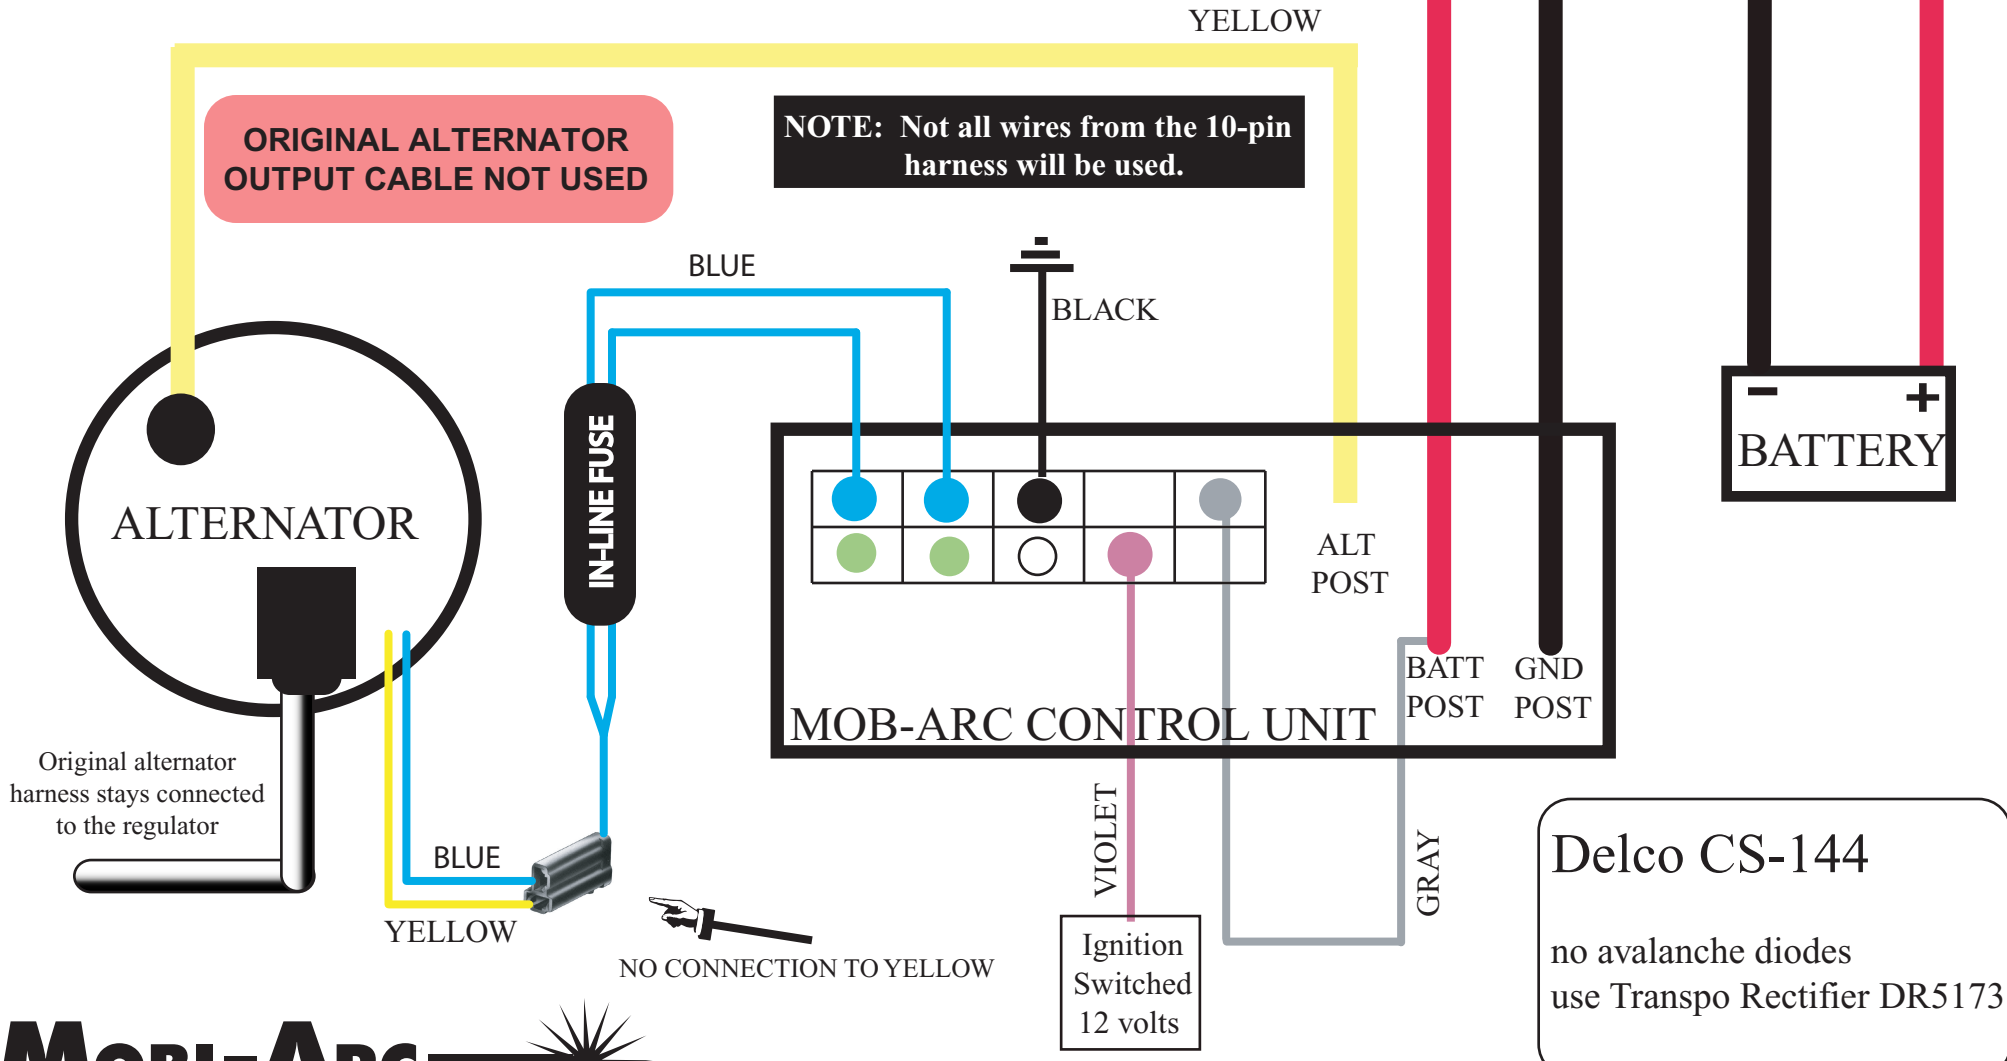
NOTE: When the original alternator harness does not mate to the alternator, a repair harness has been provided. The "F" terminal needs to be connected to switched 12 volts, no other connections on the repair harness are required. In some cases, a 10-Pin mated BYPASS Plug, when mated to the 10-pin wire harness will provide switched 12 volts automatically when the Bypass configuration is present.
